NATIONAL DAM INSPECTION REPORT. KAERCHER CREEK DAM (PA-00722), --ETC(U)

KAERCHER CREEK DAM  
BERKS COUNTY, PENNSYLVANIA  
NATIONAL I.D. NO. PA 00722

PHASE I INSPECTION REPORT  
NATIONAL DAM INSPECTION PROGRAM

Name of Dam: Kaercher Creek Dam  
County Located: Berks County  
State Located: Pennsylvania  
Stream: Kaercher Creek  
Coordinates: Latitude 40° 33.4' Longitude 75° 58.2'  
Date of Inspection: 18 July 1978

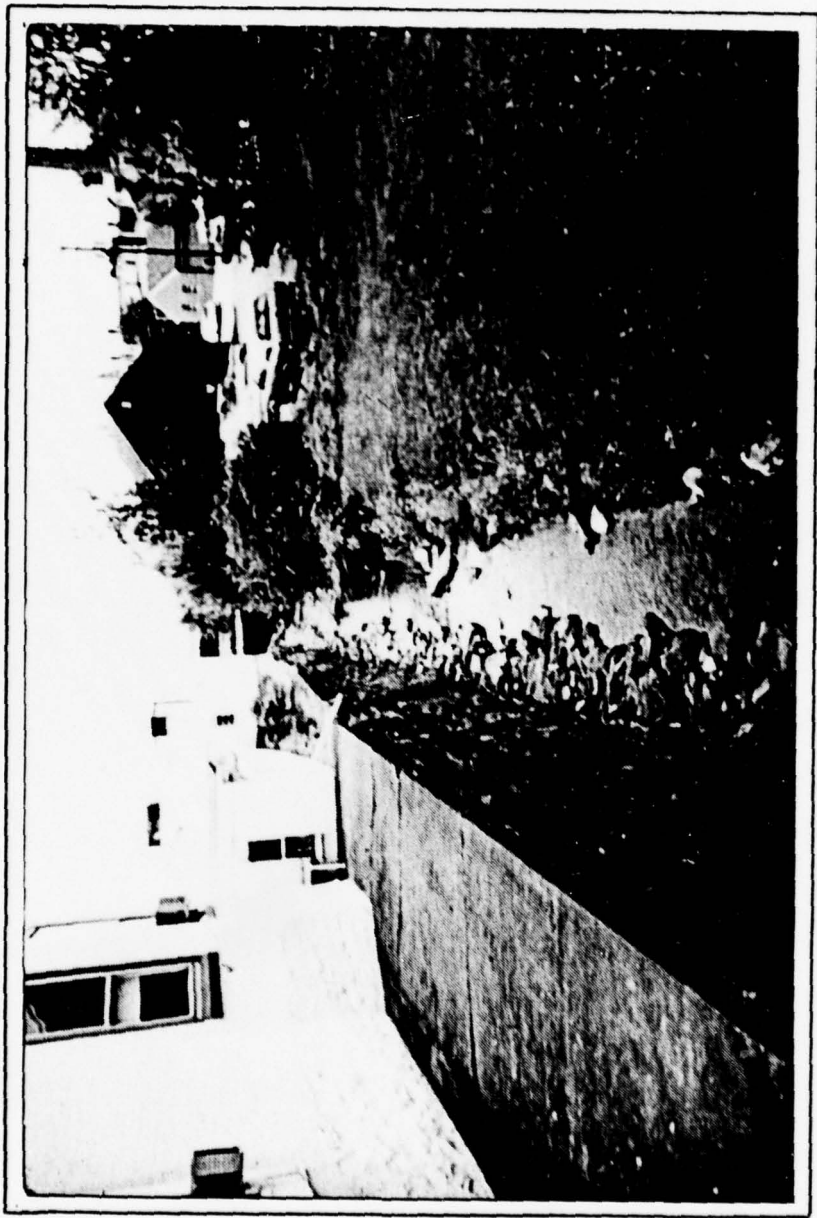
There was no debris noted in the reservoir or near the principal and emergency spillways. Downstream, significant debris and factory storage areas were noted on the flood plain. It is judged that, in the event of high flows along Kaercher Creek, debris would most likely be floated down the channel and would probably clog either the entrance to the tunnel or at the bend in the tunnel under the Hamburg Plow Works factory. This would store water eventually causing damage to the factory and to the homes in Hamburg. Additional evaluations of the flooding potential in Hambrug should be performed.

KAERCHER CREEK STREAM CHANNEL THROUGH  
THE TOWN OF HAMBURG, PENNSYLVANIA.
